**Flood Control Project Maintenance  
Levee Inspections**

**Maintenance Issue Types Only, Levee Inspection Report By Mile - Fall 2018**

**Sacramento River West Side Levee District**

Waterway	Bank	Unit Miles	Inspection Start/End	Inspector
Unit No. 01 Sacramento River	Right	49.64	10/10/2018 10/10/2018	Zach Jojola

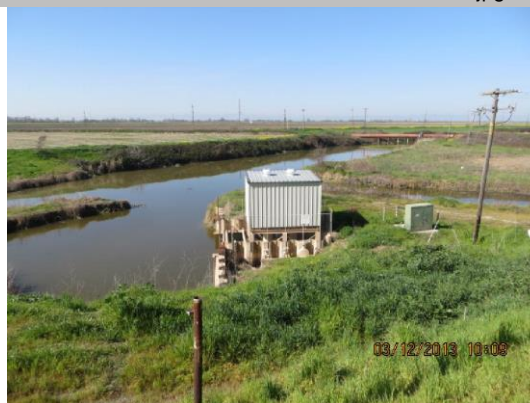
Photo 1 of 3 : UCIP\_FA\_2018\_10087\_17235.jpg

LM Start	0.14	Rating **	M	Issue No.	1551
LM End	0.14	Issue Type +	Ma	Location *	
Category	Supplemental			GPS Latitude/Longitude	
				Start	End
Item	DWR UCIP LMA Responsibility			38.801471 °	38.801471 °
				-121.725171 °	-121.725171 °
DWR ID	20224				
Comment Code					
Inspector Comment					
FS_ID:10087					
DS_ID:20224					
EP_NO: N/A					
Repair Type: Non-Urgent					
Crossing Status: Found					
UCIP Comments: Headwall on WS undermined about 3-4-feet.					
FIELD_STRUCT_DESC: 1 of 3: 36-inch steel drainage pipe through the					
levee, 30.0 feet below the crown. Flap gate on the waterside (WS) end.					
24-inch pipe sleeved through the 36-inch pipe. Annular space between					
pipes grouted. Pumps in pump house with walkway on landside (LS)					
toe. [Additional Reference(s): DWR Levee Log, 2006. USACE					
Sacramento O&M Manual 130, May 1960 (HLM 0.15)].					
FS Date: 3/12/2013

Pumphouse at LS toe.

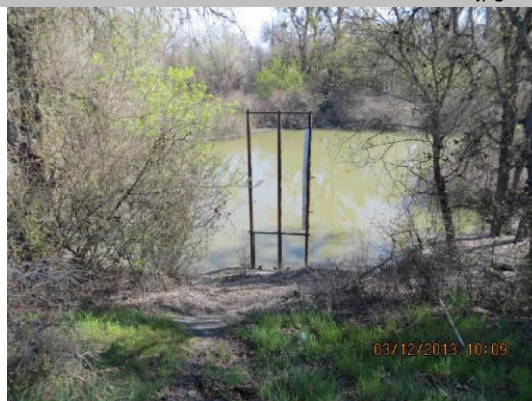
Photo 2 of 3 : UCIP\_FA\_2018\_10087\_17234.jpg

Air vents at outlet on WS toe.

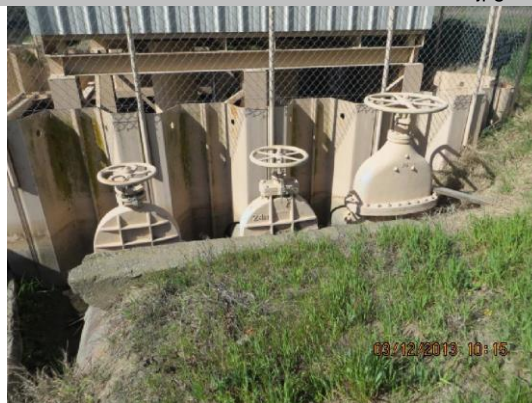
Photo 3 of 3 : UCIP\_FA\_2018\_10087\_17233.jpg

Slide gates at pumphouse on LS toe.

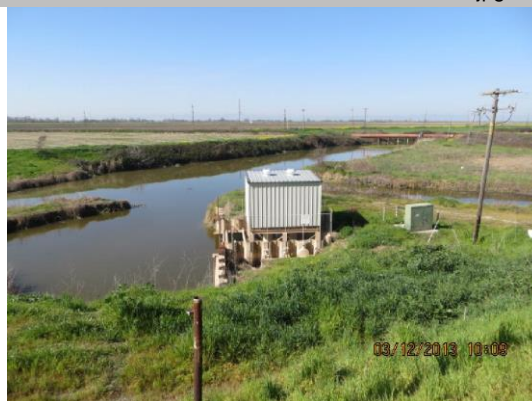
Photo 1 of 3 : UCIP\_FA\_2018\_10085\_17227.jpg

LM Start	0.14	Rating **	M	Issue No.	1552
LM End	0.14	Issue Type +	Ma	Location *	
Category	Supplemental			GPS Latitude/Longitude	
				Start	End
Item	DWR UCIP LMA Responsibility			38.801479 °	38.801479 °
				-121.725176 °	-121.725176 °
DWR ID	20356				
Comment Code					
Inspector Comment					
FS_ID:10085 DS_ID:20356 EP_NO: N/A Repair Type: Non-Urgent Crossing Status: Found UCIP Comments: Headwall undermined 3-4-feet on WS toe. FIELD_STRUCT_DESC: 2 of 3: 36-inch steel drainage pipe through the levee, 30 feet below the crown. Flap gate on the waterside (WS) end. 24-inch pipe sleeved through the 36-inch pipe. Annular space between pipes grouted. Pumps inside pump house with a walkway on the landside (LS) toe. [Additional Reference(s): DWR Levee Log, 2006. USACE Sacramento O&M Manual 130, May 1960 (HLM 0.15)]. FS Date: 3/12/2013

Pump house on LS toe.

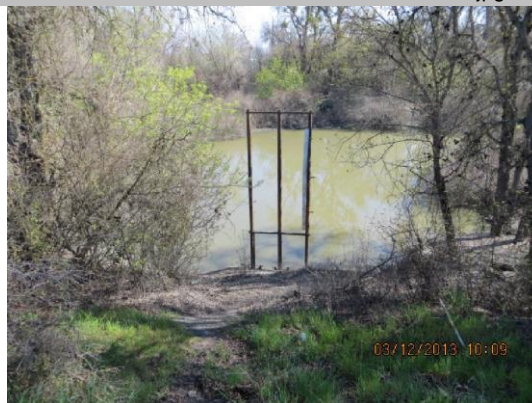
Photo 2 of 3 : UCIP\_FA\_2018\_10085\_17226.jpg

Air vents on pipes at WS toe.

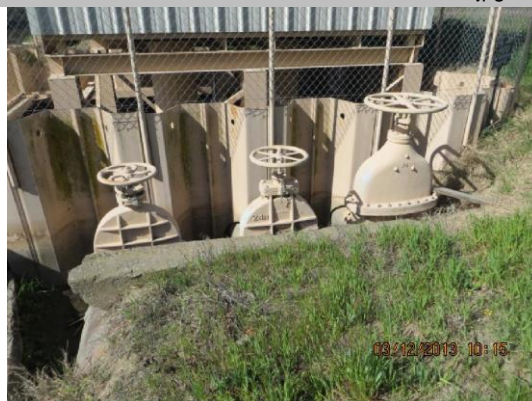
Photo 3 of 3 : UCIP\_FA\_2018\_10085\_17225.jpg

Slide gates at pumphouse on LS toe.

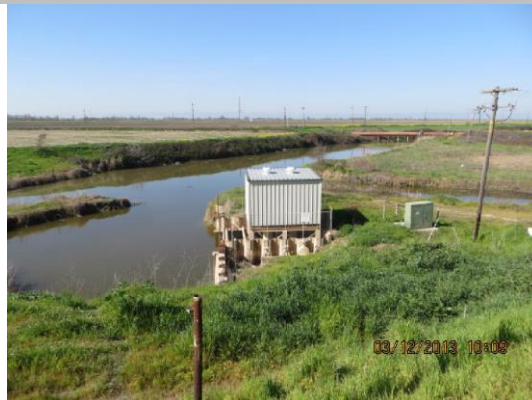
Photo 1 of 3 : UCIP\_FA\_2018\_10910\_18185.jpg

LM Start	0.14	Rating **	M	Issue No.	1553	
LM End	0.14	Issue Type +	Ma	Location *		
Category	Supplemental			GPS Latitude/Longitude		
				Start	End	
Item	DWR UCIP LMA Responsibility			38.801491 °	38.801491 °	
				-121.725184 °	-121.725184 °	
DWR ID	20357					
Comment Code						
Inspector Comment						
FS_ID:10910 DS_ID:20357 EP_NO: N/A Repair Type: Non-Urgent Crossing Status: Found UCIP Comments: Headwall undermined 3-4-feet on WS toe. FIELD_STRUCT_DESC: 3 of 3: 36-inch steel drainage pipe through the levee, 30 feet below the crown. Flap gate on the waterside (WS) end. 24-inch pipe sleeved through the 36-inch pipe. Annular space between pipes grouted. Pumps inside pump house with a walkway on the landside (LS) toe. [Additional Reference(s): DWR Levee Log, 2006. USACE Sacramento O&M Manual 130, May 1960 (HLM 0.15)]. FS Date: 3/12/2013

Pumphouse on LS toe.

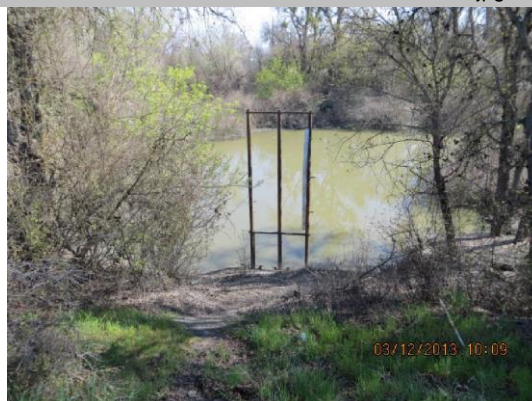
Photo 2 of 3 : UCIP\_FA\_2018\_10910\_18184.jpg

Air vents on pipes at WS toe.

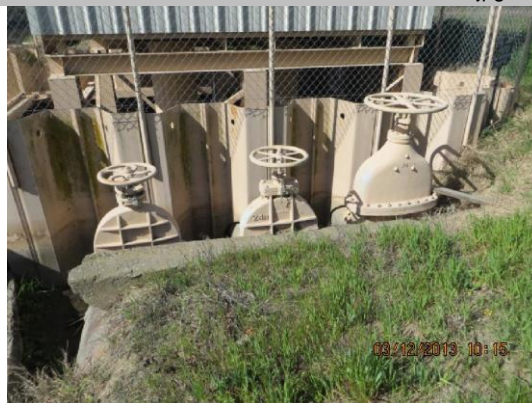
Photo 3 of 3 : UCIP\_FA\_2018\_10910\_18183.jpg

Slide gates at pumphouse on LS toe.

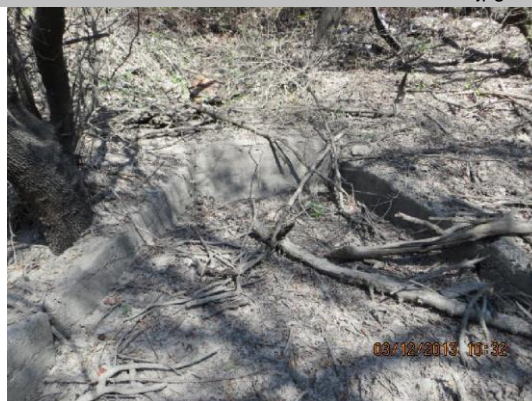
Photo 1 of 1 : UCIP\_FA\_2018\_10088\_17237.jpg

LM Start	0.22	Rating **	A/W	Issue No.	1554	
LM End	0.22	Issue Type +	Ma	Location *		
Category	Supplemental			GPS Latitude/Longitude		
				Start	End	
Item	DWR UCIP LMA Responsibility			38.802293 °	38.802293 °	
				-121.724847 °	-121.724847 °	
DWR ID	20327					
Comment Code						
Inspector Comment						
FS_ID:10088						
DS_ID:20327						
EP_NO: N/A						
Repair Type: No Action Needed						
Crossing Status: Found						
UCIP Comments:						
FIELD_STRUCT_DESC: *ABANDONED* 42-inch drainage pipe of an unknown material through the levee, 28.5 feet below the crown.						
Abandoned in place by plugging with concrete. Headwall on waterside (WS) toe. [Additional Reference(s): USACE Sacramento O&M Manual 130, May 1960 (HLM 0.22)].						
FS Date: 3/12/2013

Concrete headwall visible on WS toe.

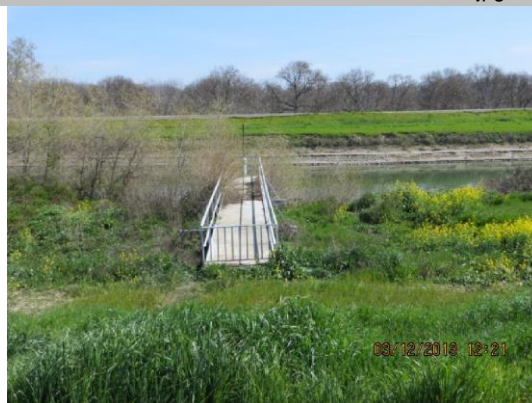
Photo 1 of 3 : UCIP\_FA\_2018\_10125\_17283.jpg

LM Start	3.54	Rating **	A/W	Issue No.	1556
LM End	3.54	Issue Type +	Ma	Location *	
Category	Supplemental			GPS Latitude/Longitude	
				Start	End
Item	DWR UCIP LMA Responsibility		38.846492 °	38.846492 °	
			-121.730066 °	-121.730066 °	
DWR ID	20331				
Comment Code					
Inspector Comment					
FS_ID:10125					
DS_ID:20331					
EP_NO: N/A					
Repair Type: No Action Needed					
Crossing Status: Found					
UCIP Comments:					
FIELD_STRUCT_DESC: 5-foot by 5-foot reinforced concrete box drainage tunnel through the levee, 33 feet below the crown. Slide gate at outlet on the waterside (WS) toe. Tunnel runs from concrete U-shaped riser unit on the landside (LS) shoulder to the WS toe. Steel walkway to slide gate actuator on the WS berm. [Additional Reference(s): USACE Sacramento O&M Manual 130, May 1960 (HLM 3.59)].					
FS Date: 3/12/2013

Steel walkway on WS berm with Slide gate actuator.

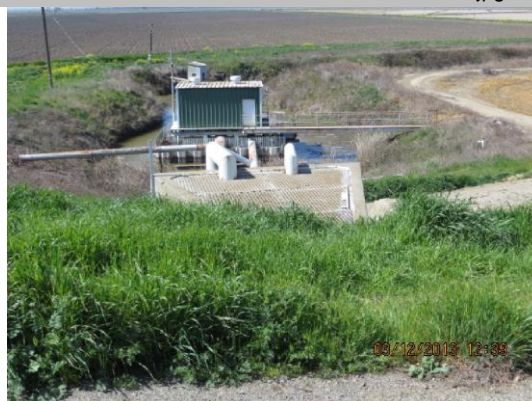
Photo 2 of 3 : UCIP\_FA\_2018\_10125\_17282.jpg

Pumphouse at LS toe and concrete riser on LS shoulder.

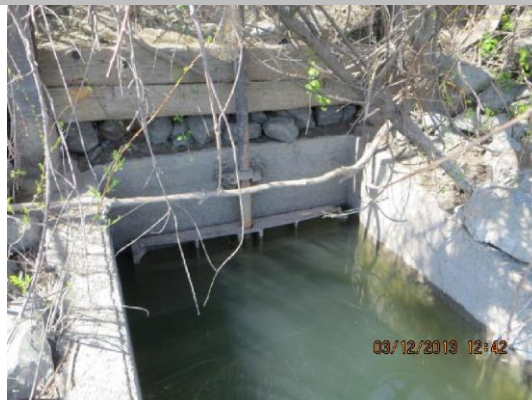
Photo 3 of 3 : UCIP\_FA\_2018\_10125\_17281.jpg

Slide gate at outlet at river side.

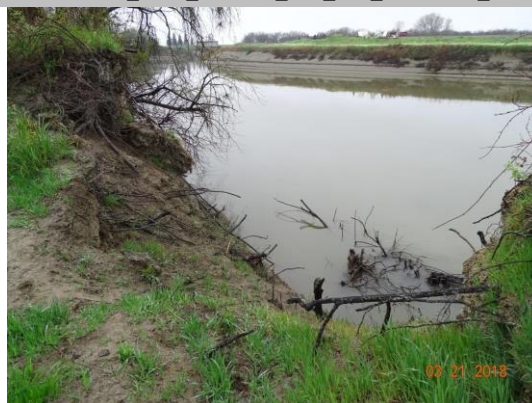
Photo 2 of 3 : FA\_2018\_NA0016\_435\_112\_20180904\_00029.jpg

View of the remaining roots, facing upstream. Spring 2018.

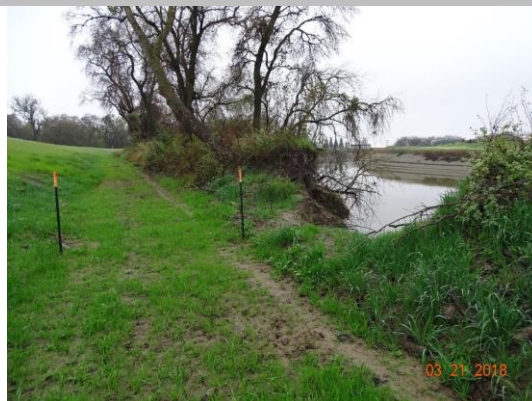
Photo 3 of 3 : FA\_2018\_NA0016\_435\_112\_20180904\_00030.jpg

Additional view of the berm. Spring 2018.

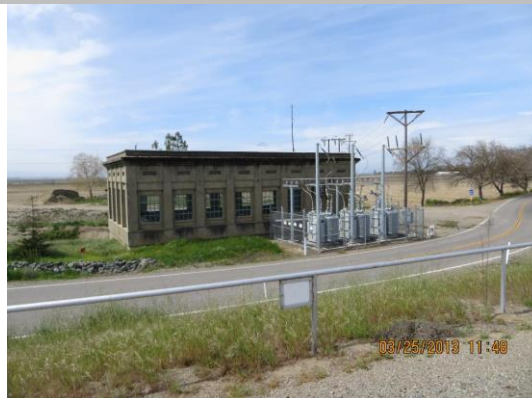
Photo 1 of 3 : UCIP\_FA\_2018\_10146\_17312.jpg

Comment Code						
Inspector Comment						
FS_ID:10146 DS_ID:20230 EP_NO: 9376 Repair Type: No Action Needed Crossing Status: Found UCIP Comments: FIELD_STRUCT_DESC: [El Dorado Bend Pumping Plant] 1 of 4: 50-inch sleeved through existing 54-inch concrete encased steel drainage pipe through the levee, 26.5 feet below the crown. Gate valves on the waterside (WS) ends of the pipes. Walkway provided to the control valves and around the pump house on the landside (LS). Pipes originate in a large concrete pool at the pump house on the LS. (54-inch pipe [HLM 5.27] authorized under Automatic Board Order (ABO) issued as Permit No. 9376, 1974 - Reclamation District Nos. 2047 and 108; 50-inch pipe sleeved through existing 54-inch pipe and trash rack repairs authorized under maintenance in 2013). [Additional Reference(s): DWR Levee Log, 2006. USACE Sacramento O&M Manual 130, May 1960 (HLM 8.99)]. FS Date: 3/13/2013

Pumphouse on LS toe.

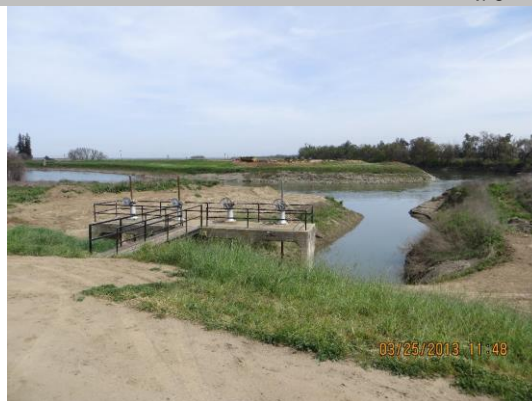
Photo 2 of 3 : UCIP\_FA\_2018\_10146\_17311.jpg

Walkway to slide gate actuators on WS shoulder.

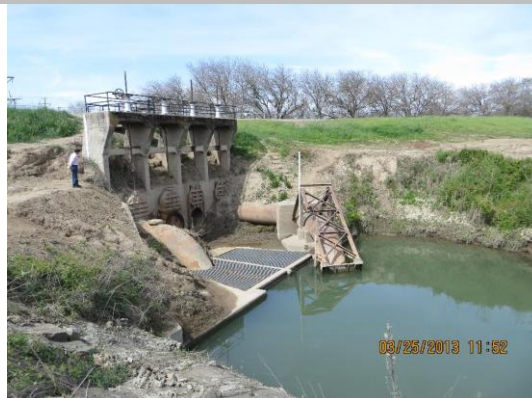
Photo 3 of 3 : UCIP\_FA\_2018\_10146\_17310.jpg

Pipes at outlet on WS toe.

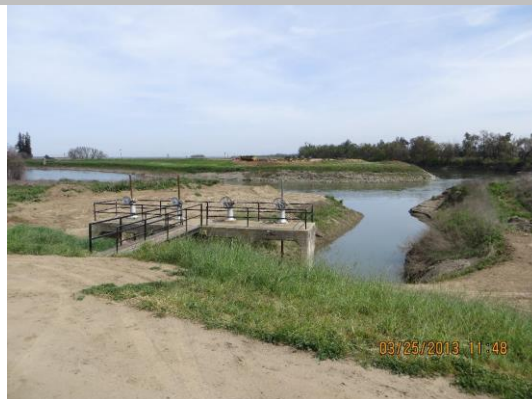
Photo 2 of 3 : UCIP\_FA\_2018\_10147\_17315.jpg

Walkway to slide gate actuators on WS shoulder.

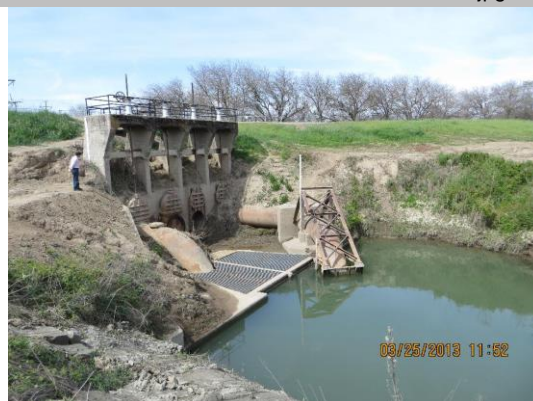
Photo 3 of 3 : UCIP\_FA\_2018\_10147\_17314.jpg

Slide gates and pipes at outlet structure on WS toe.

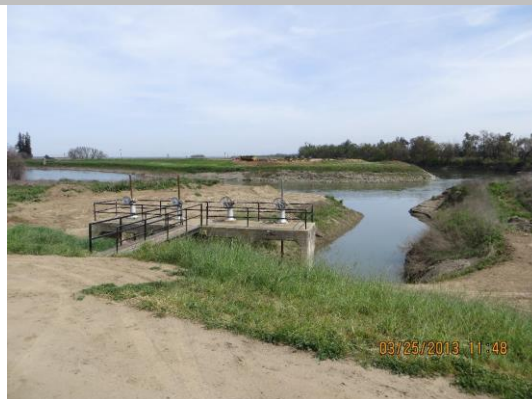
Photo 2 of 3 : UCIP\_FA\_2018\_10148\_17319.jpg

Slide gate actuators on platform at WS shoulder.

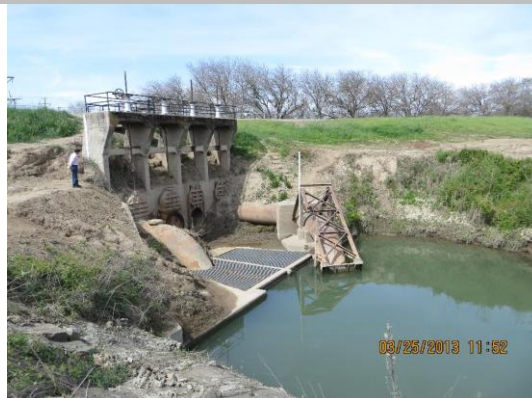
Photo 3 of 3 : UCIP\_FA\_2018\_10148\_17318.jpg

Pipes at outlet on WS.

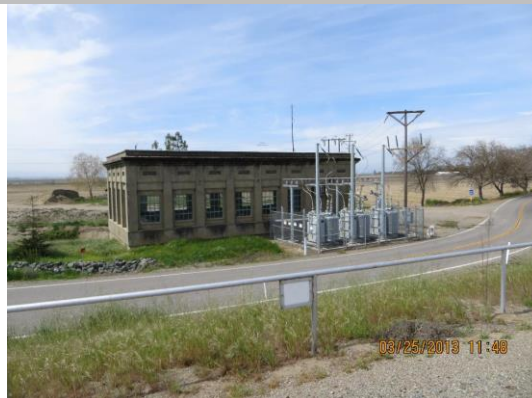
Photo 1 of 3 : UCIP\_FA\_2018\_10149\_17324.jpg

Comment Code					
Inspector Comment					
FS_ID:10149					
DS_ID:20363					
EP_NO: 9376					
Repair Type: No Action Needed					
Crossing Status: Found					
UCIP Comments:					
FIELD_STRUCT_DESC: [El Dorado Bend Pumping Plant] 4 of 4: 50-inch sleeved through existing 54-inch concrete encased steel drainage discharge pipe through the levee, 26.5 feet below the crown. Gate valves on both ends of the pipe. Walkway provided to the control valves. (54-inch pipe [HLM 5.27] authorized under Automatic Board Order (ABO) issued as Permit No. 9376, 1974 - Reclamation District Nos. 2047 and 108; 50-inch pipe sleeved through existing 54-inch pipe and trash rack repairs authorized under maintenance in 2013). [Additional Reference(s): DWR Levee Log, 2006. USACE Sacramento O&M Manual 130, May 1960 (HLM 8.99)].					
FS Date: 3/13/2013

Pumphouse on LS.

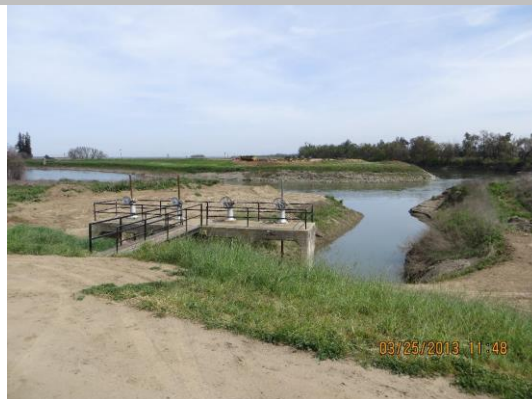
Photo 2 of 3 : UCIP\_FA\_2018\_10149\_17323.jpg

Slide gate actuators on platform at WS shoulder.

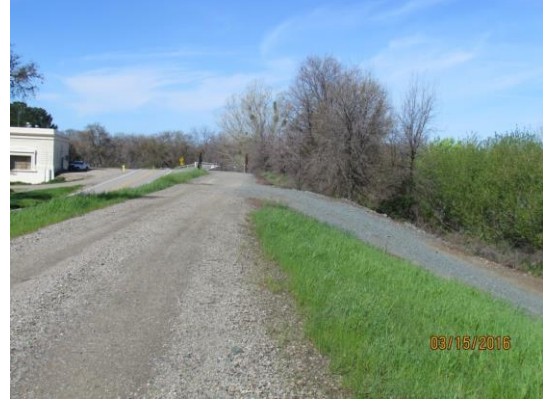
Photo 1 of 2 : FA\_2018\_NA0016\_435\_29\_20180904\_00007.jpg

View of the revegetation site on the waterward side of the levee looking upstream. Spring 2016.

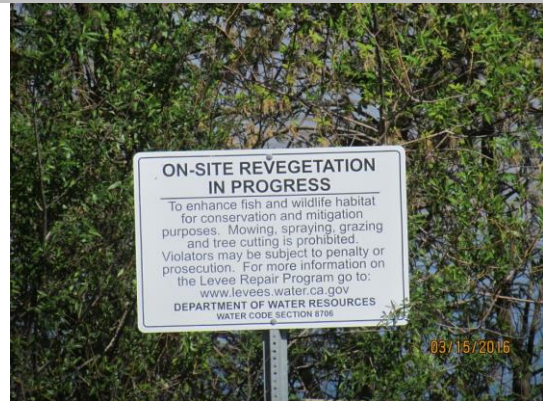
Photo 2 of 2 : FA\_2018\_NA0016\_435\_29\_20180904\_00008.jpg

Revegetation site sign. Spring 2016.

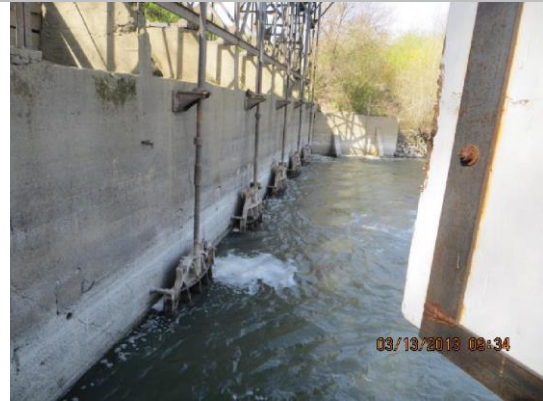
Photo 1 of 3 : UCIP\_FA\_2018\_10164\_17345.jpg

LM Start	9.75	Rating **	A/W	Issue No.	1567	
LM End	9.75	Issue Type +	Ma	Location *		
Category	Supplemental			GPS Latitude/Longitude		
				Start	End	
Item	DWR UCIP LMA Responsibility			38.862615 °	38.862615 °	
				-121.792582 °	-121.792582 °	
DWR ID	20232					
Comment Code						
Inspector Comment						
FS_ID:10164						
DS_ID:20232						
EP_NO: N/A						
Repair Type: No Action Needed						
Crossing Status: Found						
UCIP Comments:						
FIELD_STRUCT_DESC: 1 of 5: 60-inch reinforced concrete drainage culvert through the levee, 35 feet below the crown. Screw gates on walkway at waterside (WS) shoulder. Staff gauge to 47.0 feet on structure. [Additional Reference(s): DWR Levee Log, 2006. USACE Sacramento O&M Manual 130, May 1960 (HLM 9.87)].						
FS Date: 3/13/2013

Slide gates at concrete headwall at river

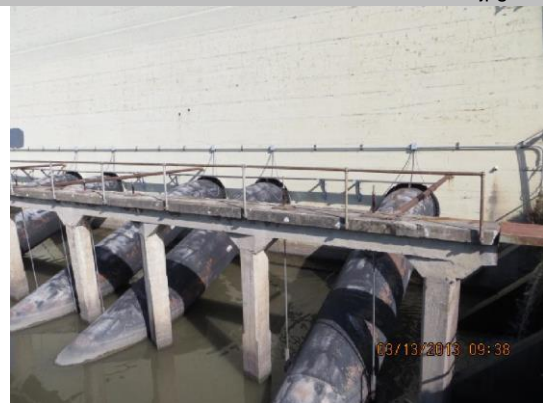
Photo 2 of 3 : UCIP\_FA\_2018\_10164\_17344.jpg

Pipes at entrance to pumping plant building on LS toe.

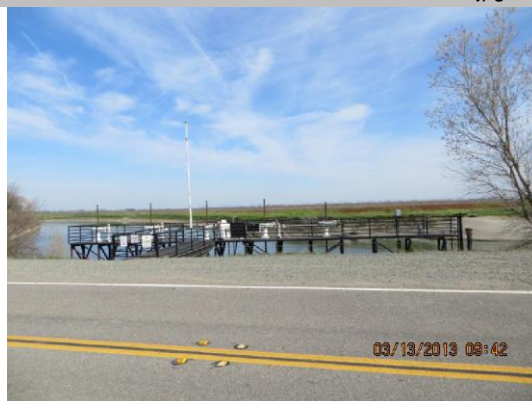
Photo 3 of 3 : UCIP\_FA\_2018\_10164\_17343.jpg

Slide gate actuators on WS shoulder.

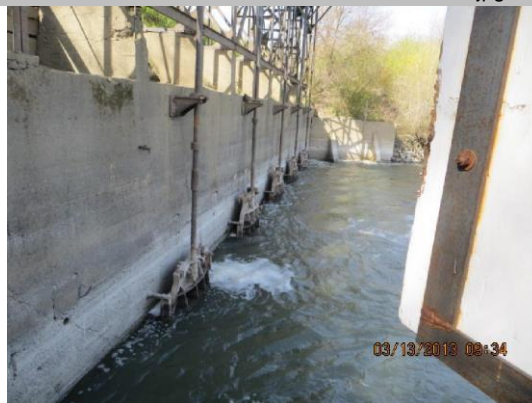
Photo 1 of 3 : UCIP\_FA\_2018\_10165\_17348.jpg

LM Start	<b>9.76</b>	Rating **	A/W	Issue No.	<b>1568</b>					
LM End	<b>9.76</b>	Issue Type +	Ma	Location *						
Category	Supplemental		GPS Latitude/Longitude							
			Start	End						
Item	DWR UCIP LMA Responsibility		38.862624 °	38.862624 °						
			-121.792626 °	-121.792626 °						
DWR ID	20364									
Comment Code										
Inspector Comment										
FS_ID:10165 DS_ID:20364 EP_NO: N/A Repair Type: No Action Needed Crossing Status: Found UCIP Comments: FIELD_STRUCT_DESC: 2 of 5: 60-inch reinforced concrete drainage culvert through the levee, 35 feet below the crown. Screw gate actuators on metal platform on the waterside (WS) shoulder. Large pumping plant building on the landside (LS) shoulder. Staff gauge to 47 feet on structure. [Additional Reference(s): DWR Levee Log, 2006. USACE Sacramento O&M Manual 130, May 1960 (HLM 9.87)]. FS Date: 3/13/2013

Slide gates and headwall on WS toe.

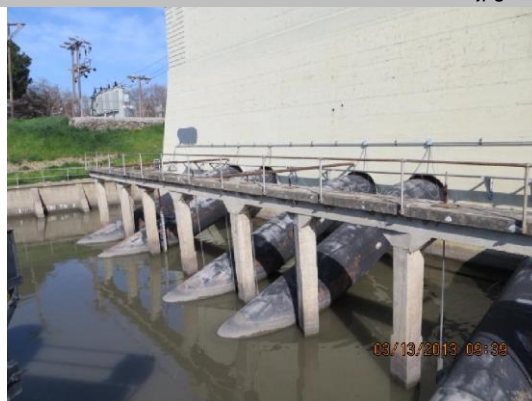
Photo 2 of 3 : UCIP\_FA\_2018\_10165\_17347.jpg

Pipes at inlet to pumphouse on LS toe.

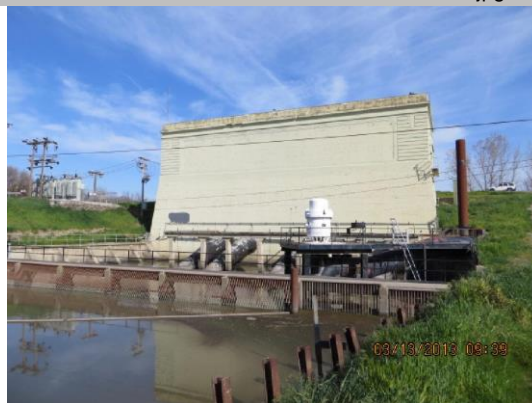
Photo 3 of 3 : UCIP\_FA\_2018\_10165\_17346.jpg

Pumphouse on LS.

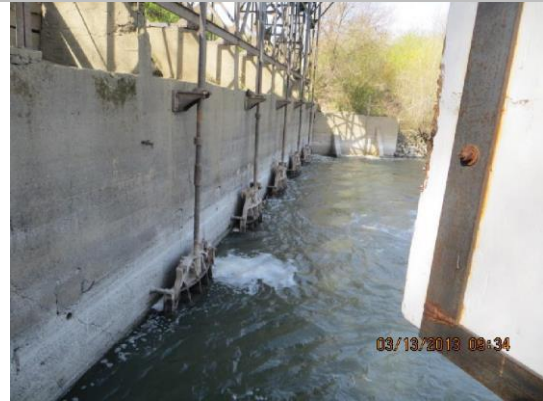
Photo 1 of 3 : UCIP\_FA\_2018\_10168\_17360.jpg

LM Start	9.76	Rating **	A/W	Issue No.	1569
LM End	9.76	Issue Type +	Ma	Location *	
Category	Supplemental			GPS Latitude/Longitude	
				Start	End
Item	DWR UCIP LMA Responsibility			38.862633 °	38.862633 °
				-121.792669 °	-121.792669 °
DWR ID	20365				
Comment Code					
Inspector Comment					
FS_ID:10168					
DS_ID:20365					
EP_NO: N/A					
Repair Type: No Action Needed					
Crossing Status: Found					
UCIP Comments:					
FIELD_STRUCT_DESC: 3 of 5: 60-inch reinforced concrete drainage culvert through the levee, 35 feet below the crown. Screw gate actuators on metal platform on the waterside (WS) shoulder. Large pumping plant building on the landside (LS) shoulder. Staff gauge to 47 feet on structure. [Additional Reference(s): DWR Levee Log, 2006. USACE Sacramento O&M Manual 130, May 1960 (HLM 9.87)].					
FS Date: 3/13/2013

Slide gate and concrete headwall on WS toe.

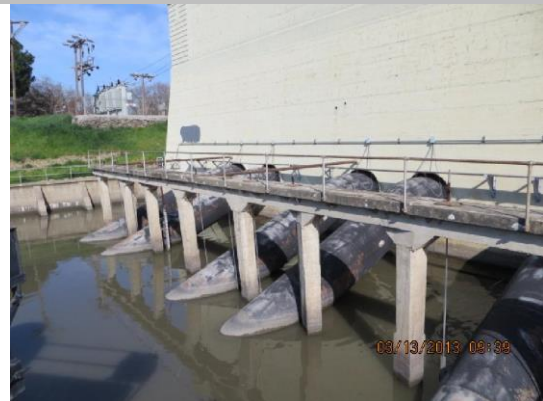
Photo 2 of 3 : UCIP\_FA\_2018\_10168\_17359.jpg

Pipe at inlet to pumphouse on LS toe.

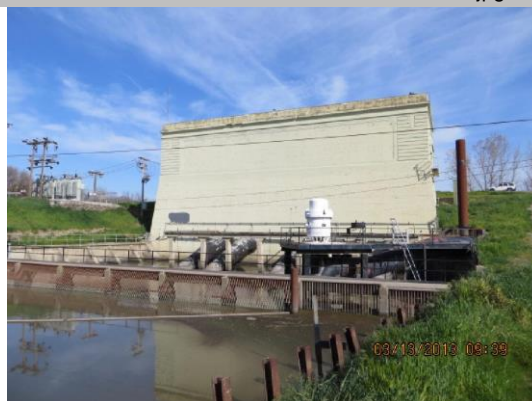
Photo 3 of 3 : UCIP\_FA\_2018\_10168\_17358.jpg

Pumphouse on LS.

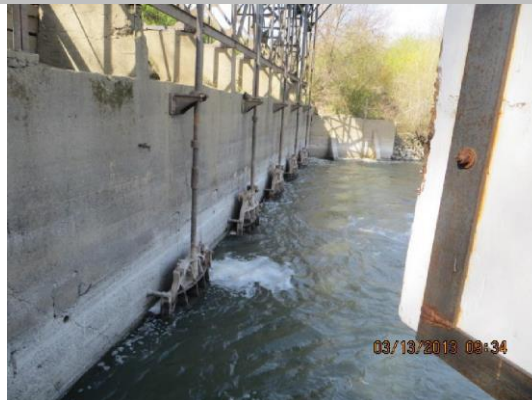
Photo 1 of 3 : UCIP\_FA\_2018\_10167\_17352.jpg

Slide gates and headwall at WS toe.

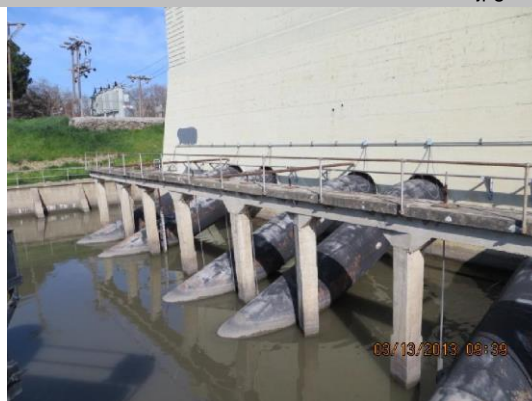
Photo 2 of 3 : UCIP\_FA\_2018\_10167\_17351.jpg

Pipes at inlet to pumping plant on LS toe.

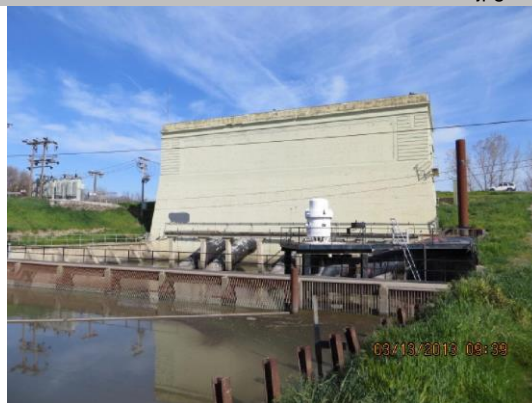
Photo 3 of 3 : UCIP\_FA\_2018\_10167\_17350.jpg

Pumping plant on LS.

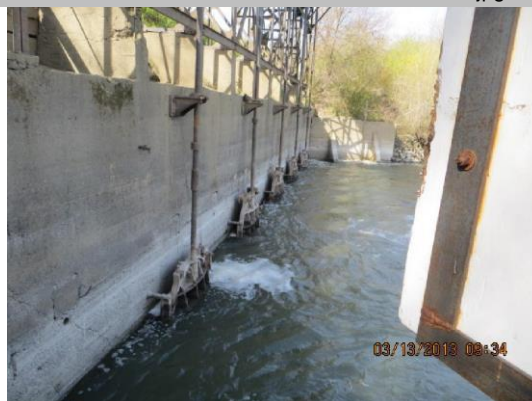
Photo 1 of 3 : UCIP\_FA\_2018\_10169\_17364.jpg

Slide gates and concrete headwall on WS toe.

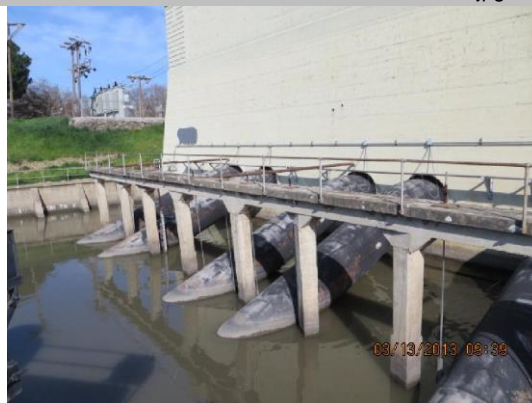
Photo 2 of 3 : UCIP\_FA\_2018\_10169\_17363.jpg

pipes at entrance to pumphouse on LS toe.

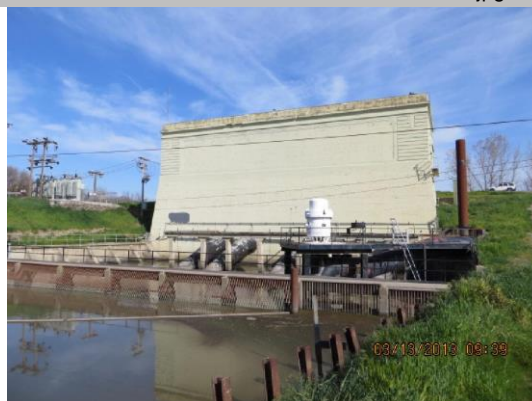
Photo 3 of 3 : UCIP\_FA\_2018\_10169\_17362.jpg

Pumphouse on LS.

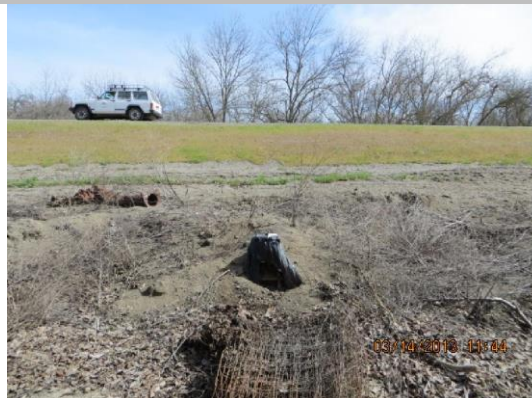
Photo 1 of 3 : UCIP\_FA\_2018\_10291\_17548.jpg

Gate valve buried on LS toe.

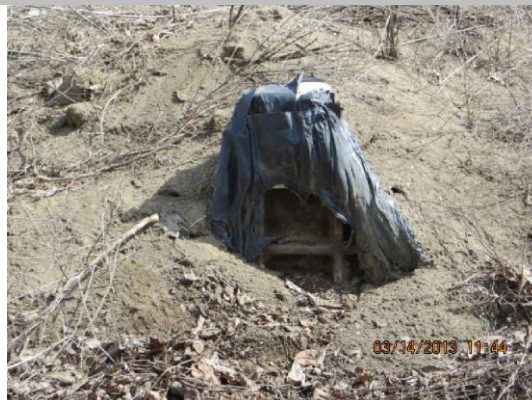
Photo 2 of 3 : UCIP\_FA\_2018\_10291\_17547.jpg

Gate valve buried on LS toe.

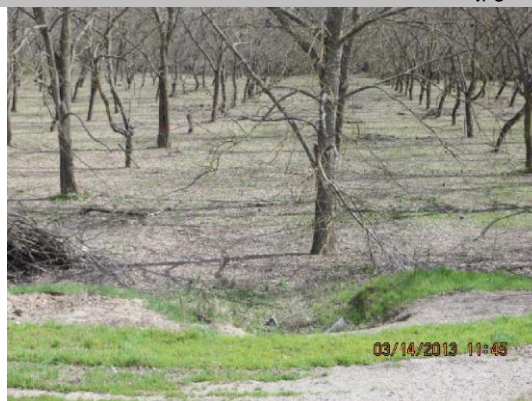
Photo 3 of 3 : UCIP\_FA\_2018\_10291\_17546.jpg

Excavation at WS toe where pipe should be.

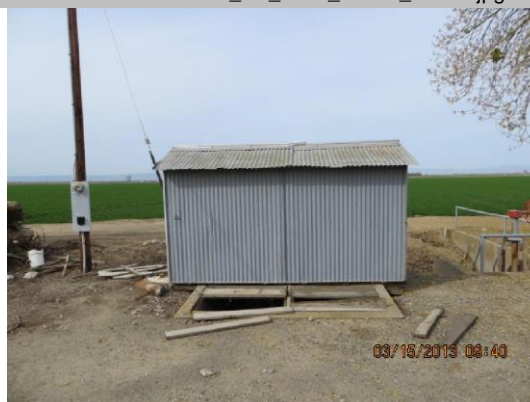
Photo 2 of 3 : UCIP\_FA\_2018\_10306\_17565.jpg

Pumphouse and sump on LS toe.

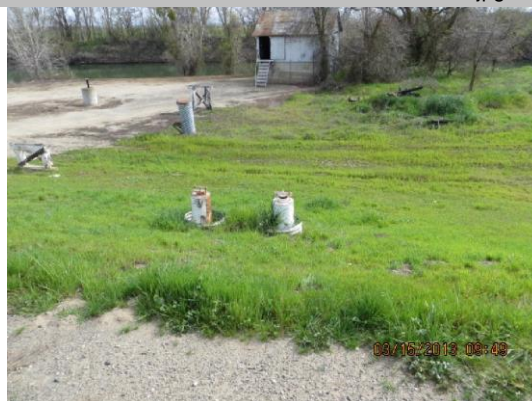
Photo 3 of 3 : UCIP\_FA\_2018\_10306\_17564.jpg

siphon breakers in CMP risers on WS slope.

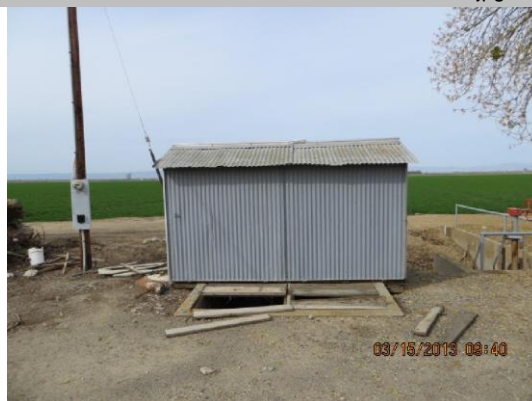
Photo 1 of 3 : UCIP\_FA\_2018\_10307\_17569.jpg

Pumphouse over sump on LS toe.

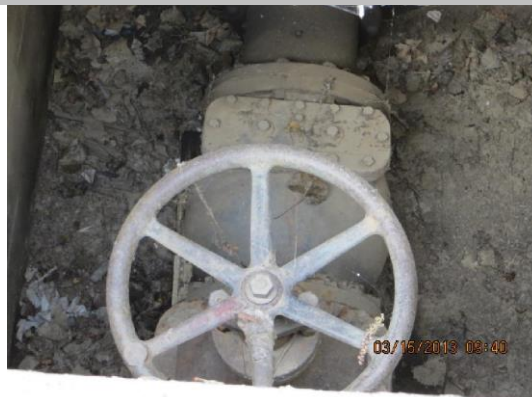
Photo 2 of 3 : UCIP\_FA\_2018\_10307\_17568.jpg

Slide gate in concrete vault under pumphouse at LS toe.

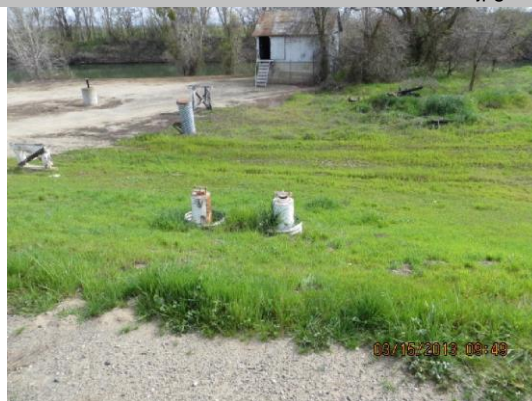
Photo 3 of 3 : UCIP\_FA\_2018\_10307\_17567.jpg

Siphon breaker in 24-inch CMP riser on WS slope.

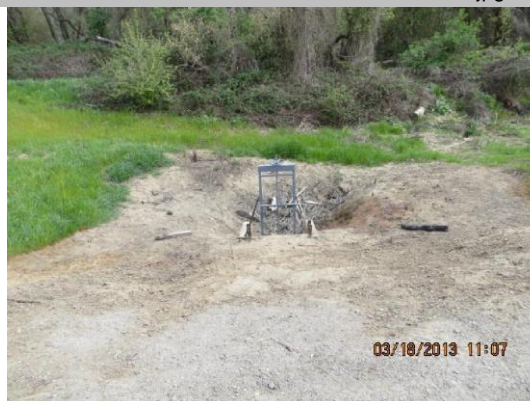
Photo 1 of 3 : UCIP\_FA\_2018\_10426\_17705.jpg

Slide gate on WS toe.

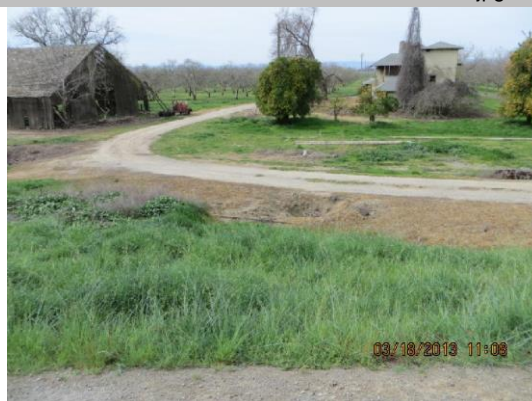
Photo 2 of 3 : UCIP\_FA\_2018\_10426\_17704.jpg

Headwall and gate valve on LS toe buried but partially exposed.

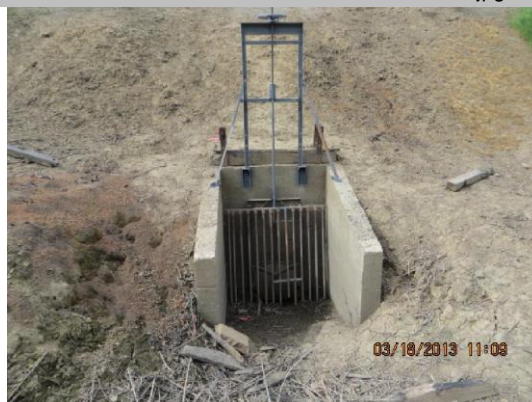
Photo 3 of 3 : UCIP\_FA\_2018\_10426\_17703.jpg

Outlet/inlet on WS toe.

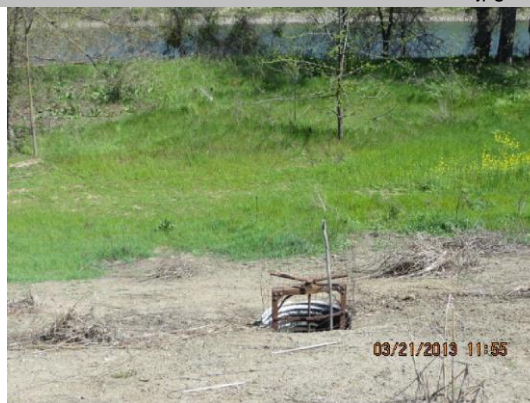
Photo 1 of 3 : UCIP\_FA\_2018\_10535\_17877.jpg

Slide gate in CMP riser on WS slope.

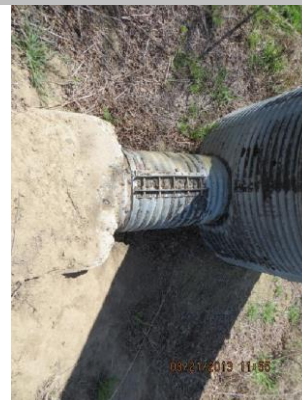
Photo 3 of 3 : UCIP\_FA\_2018\_10535\_17875.jpg

24-inch CMP at connection to CMP riser on LS toe.

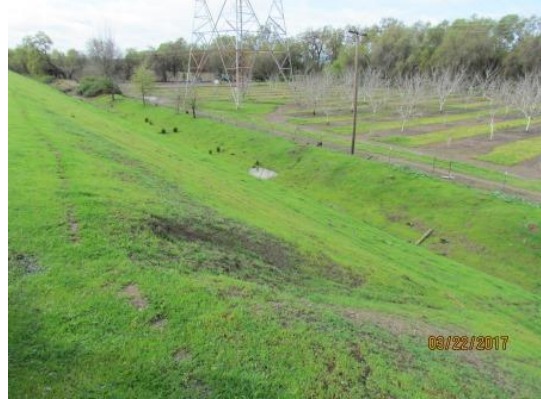
Photo 1 of 2 : FA\_2018\_NA0016\_435\_146\_20180904\_00046.jpg

Slope stability issue due to foot traffic. Spring 2017.

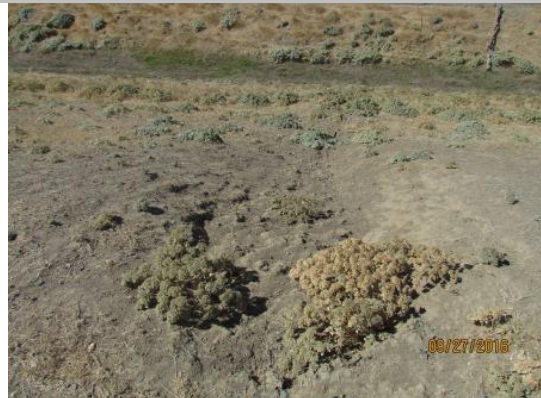
Photo 2 of 2 : FA\_2018\_NA0016\_435\_146\_20180904\_00047.jpg

Slope stability issue due to foot traffic. Fall 2016 inspection.

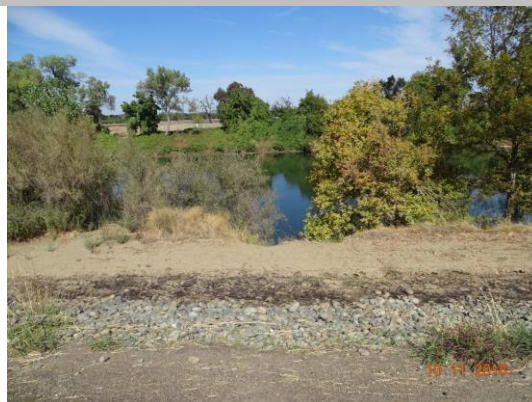
Photo 1 of 1 : FA\_2018\_NA0016\_435\_113\_20181011\_00229.jpg

View of erosion on the waterside berm. Fall 2018.
